Goff Engineering & Surveying, Inc.

Project: Pine River Ranches #2 Subdivision

Date: May 9, 2018

Re: Bridge Structure Assessment

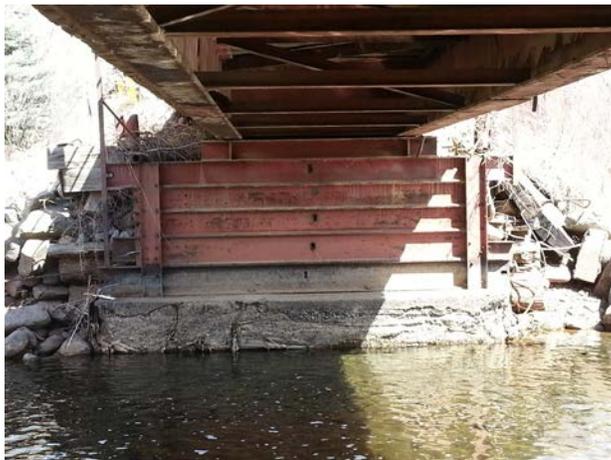
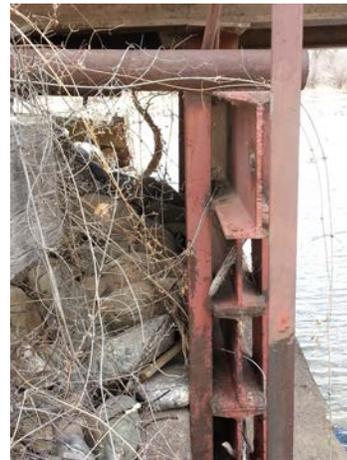
**East Bridge Abutment:** The east bridge abutment consists of horizontally stacked steel wide flange beams, with vertical steel channels embedded in a concrete foundation.

The east bridge abutment has experienced deterioration and settlements. Since the abutment is retaining soil, the lateral loads applied to the abutment has caused the top to deflect towards the river. Although the east abutment has been performing over the years, the abutment capacity is suspect and does not meet current AASHTO codes.

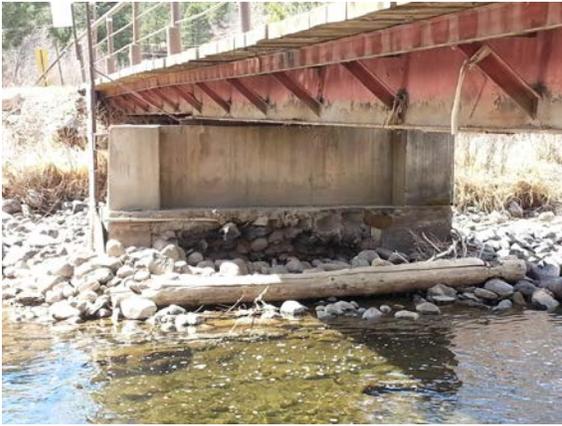
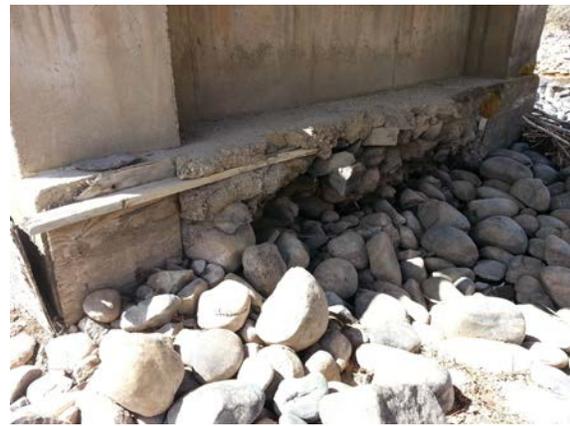
**Central Bridge Pier:** The central pier has experienced scour, undermining the central pier foundation.

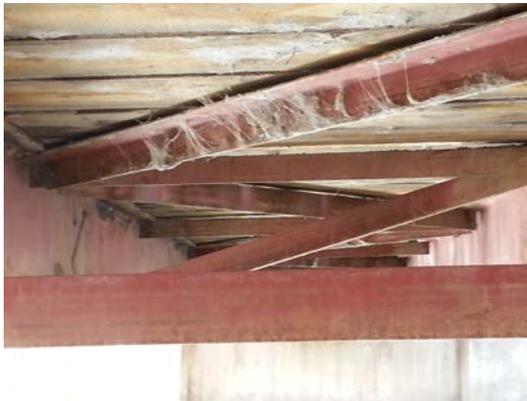
Underside of Bridge Decking

**Bridge Decking:** Based on the many different vehicles using the bridge, many heavier construction vehicles, and the many different users, we consider the bridge decking to be not adequate, and poses a safety concern. The bridge decking is only adequate if the vehicles remain centered over the bridge girders below. If vehicles with heavier wheel loads veer to one side, loading the cantilevered portion of the decking, the decking will fail.

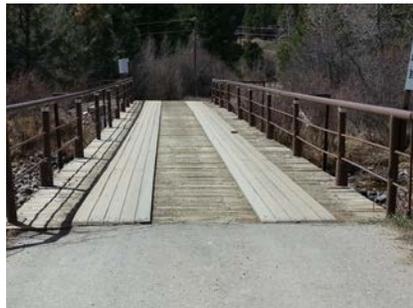
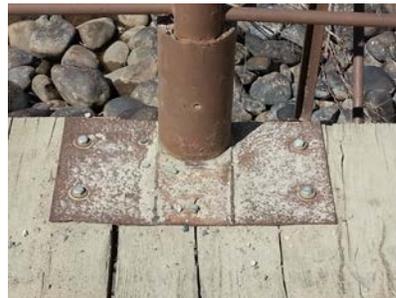
**Bridge Guardrail:** The bridge guardrails are not in compliance with AASHTO code for strength or geometry. We consider the guardrails as very deficient and not safe. If a vehicle veers into the guardrail, and if the bridge decking does not fail first, the guardrail will certainly fail.

In summary, the subdivision bridge structure has performed and provided access for the past 30 years. However considering the population growth the subdivision has experienced, along the increased use of the bridge, we consider the overall bridge structure to be unsafe. We highly recommend the one-lane bridge be replaced with a new two-lane bridge, with a minimum 24-foot width, designed in accordance with current AASHTO code. If a second emergency access to the subdivision cannot be accomplished, we recommend the bridge width be 30-foot minimum.
